National Energy
Board

**Investigation Under the
National Energy Board Act
into the Death of
Mr. Henri St. Pierre at the
Enbridge Pipelines Inc.
Kerrobert Pump Station on
24 March 2008**

February 2009

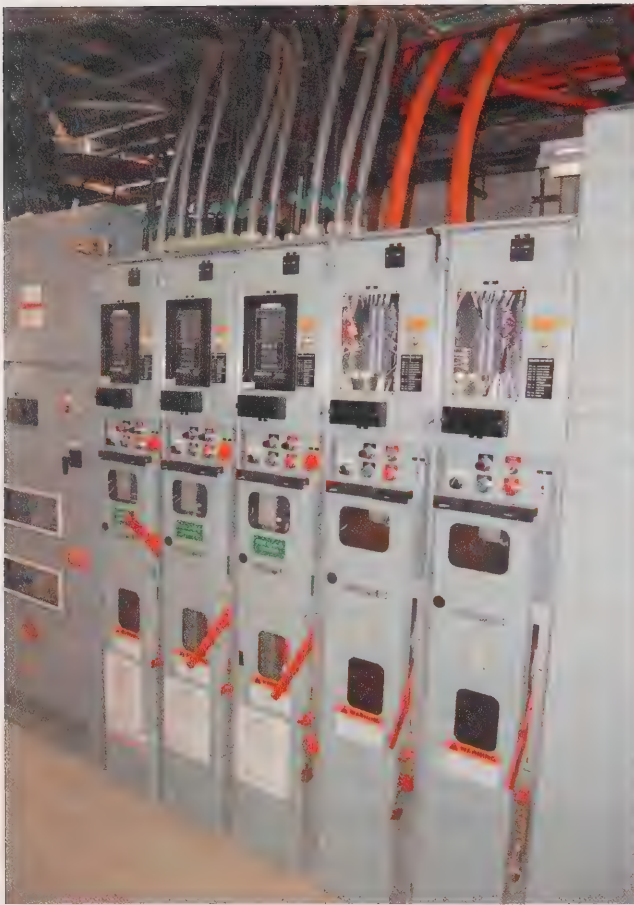
Photo 5.1 shows the bank of five unit starters left undisturbed immediately following the incident as required by section 127(1) of the CLC. The unit starters are numbered from 4-U-1 to 4-U-5 in sequence from left to right. The photo shows that starters 4-U-2 and 4-U-3 are in the racked out position (indicated by the red levers in the down position). A lock is applied to starter 4-U-3; however a lock is not applied to starter 4-U-2 due to the emergency nature of racking out this starter immediately following the incident. Starters 4-U-4 and 4-U-5 are extra starters, which were not in use and not connected to equipment at the time of the incident.

Photo 5.1: Unit starters located in 4-ESB-1 building.

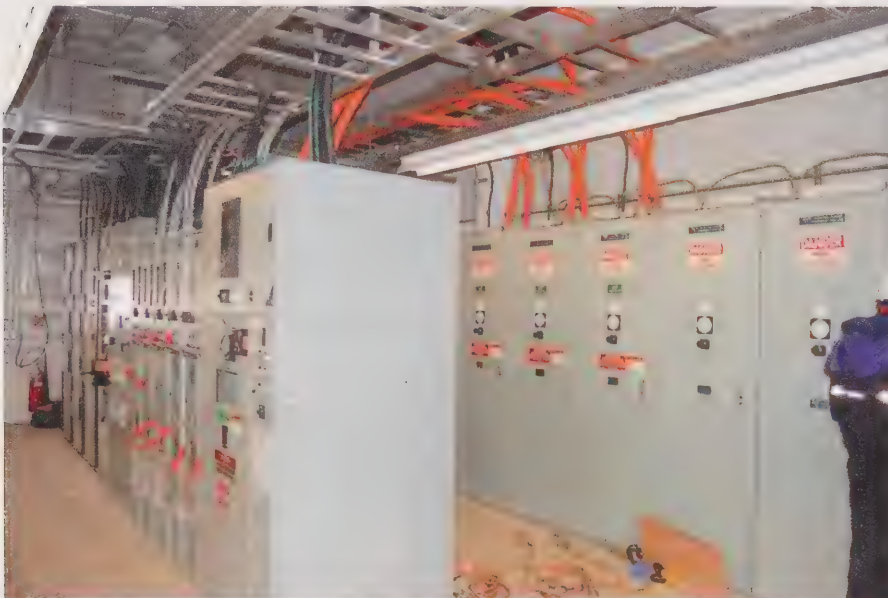
Photo 5.2 shows the relative positions of the five unit starters (left) and the five power factor capacitor cells (right). The grounding cables in use at the time of the incident can be seen lying on the floor in front of the power factor capacitor cells. Also seen in the photo is the overhead lighting that was used by Mr. Halter to test the function of the voltage probe prior to conducting a sweep inside the cell with the probe.

Photo 5.2: Unit starters and power factor capacitor cells.

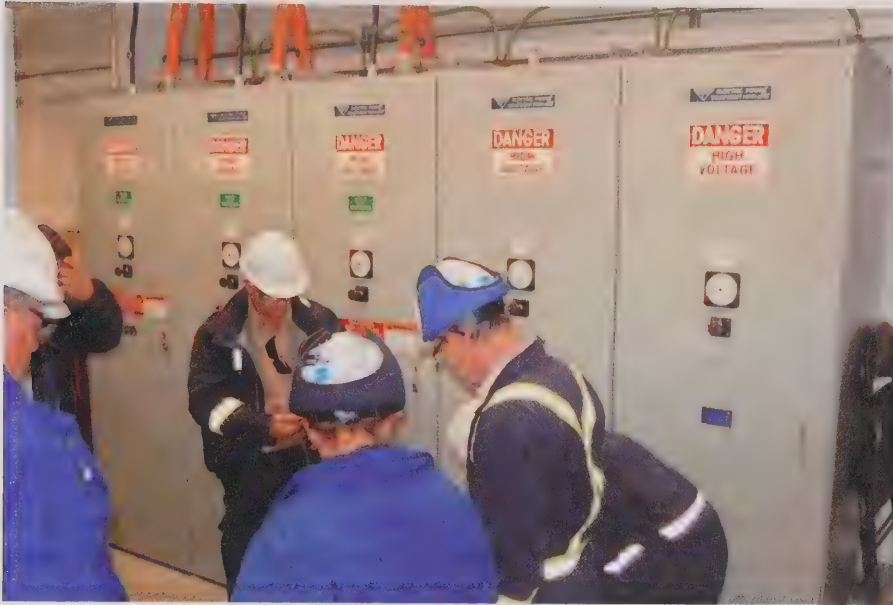
Photo 5.3 shows the bank of five power factor capacitor cells. The power factor capacitor cells are numbered from 4-U-1 to 4-U-5 in sequence from left to right.

Photo 5.3: Power factor capacitor cells.

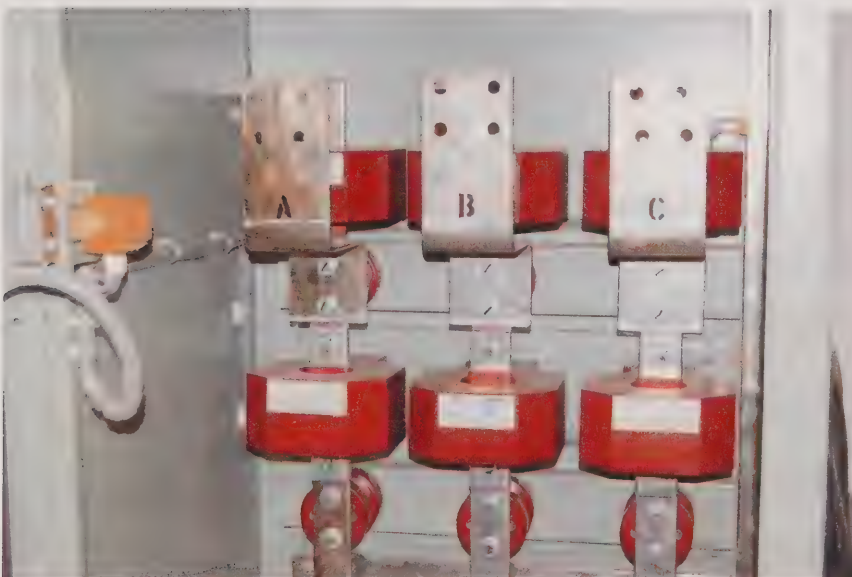
Photo 5.4 shows the inside of power factor capacitor cell 4-U-2. The metal bus bars are labeled A, B and C. After racking out the unit, grounding is accomplished by connecting the three tail ends of the grounding cables to the three bus bars and then the lead end of the grounding cables to a ground point.

Photo 5.4: inside of power factor capacitor cell 4-U-2.

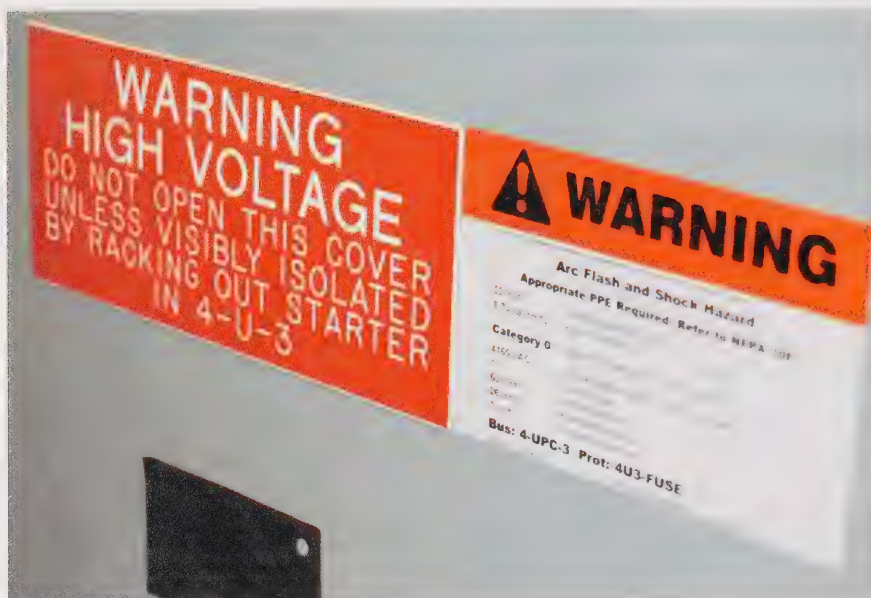
Photo 5.5: Warning labels on outside of door to power factor capacitor cell 4-U-3. The labeling is common to all power factor capacitor cells in 4-ESB-1.

At the time of the incident Mr. St. Pierre was not wearing the appropriate PPE as required by Book 2 procedures, Enbridge training requirements, NFPA 70E and as indicated on the warning label on the outside of the power factor capacitor cell door. In addition to the fire protective clothing that Mr. St. Pierre was wearing, he should also have been wearing safety glasses, hard hat and high voltage gloves. The Board notes that in response to IR2-5c, Enbridge included the details of the High Voltage Training module that was provided to Mr. St. Pierre and Mr. Halter. The High Voltage Training module emphasized the need for and the requirement to wear high voltage gloves for applying safety grounds. The evidence also indicates that throughout his work history, Mr. St. Pierre was very diligent about wearing the proper PPE and Enbridge did not have reason to be concerned about Mr. St. Pierre's compliance with requirements for PPE. Therefore, it may never be known why Mr. St. Pierre did not wear the proper PPE at the time of the incident. PPE was Mr. St. Pierre's last line of defence when all other systems failed.

The Board notes that Enbridge has assigned flash hazard number HRC-0 to the power factor capacitor cells in the Enbridge 4-ESB-1 building (photograph 5). The Board also notes the requirements of NFPA 170E to conduct a Shock Hazard Analysis, a Flash Hazard Analysis and, through calculations provided in Annex D, to determine Flash Protection Boundaries and incident energy exposure of a worker. However, these calculations do not determine a HRC number for flash protection. The standard allows for determination of the HRC number and PPE requirements using section 130.7(C)(9) in lieu of the detailed flash hazard analysis approach.

- Demonstrate how the Hazard/Risk Category number 0 was determined for the power factor capacitor cells in 4-ESB-1.
- Re-assess the Hazard/Risk Category number assigned to the cells.
